Smiths Interconnect Qualification Test Report
Report No: TML_QUAL_111
Revision A

ISO-SPLITTER (1:2)

This document describes the Test Qualification of product XPD303 Iso-Splitter (1:2). An internal platform qualification for Smiths Interconnect.

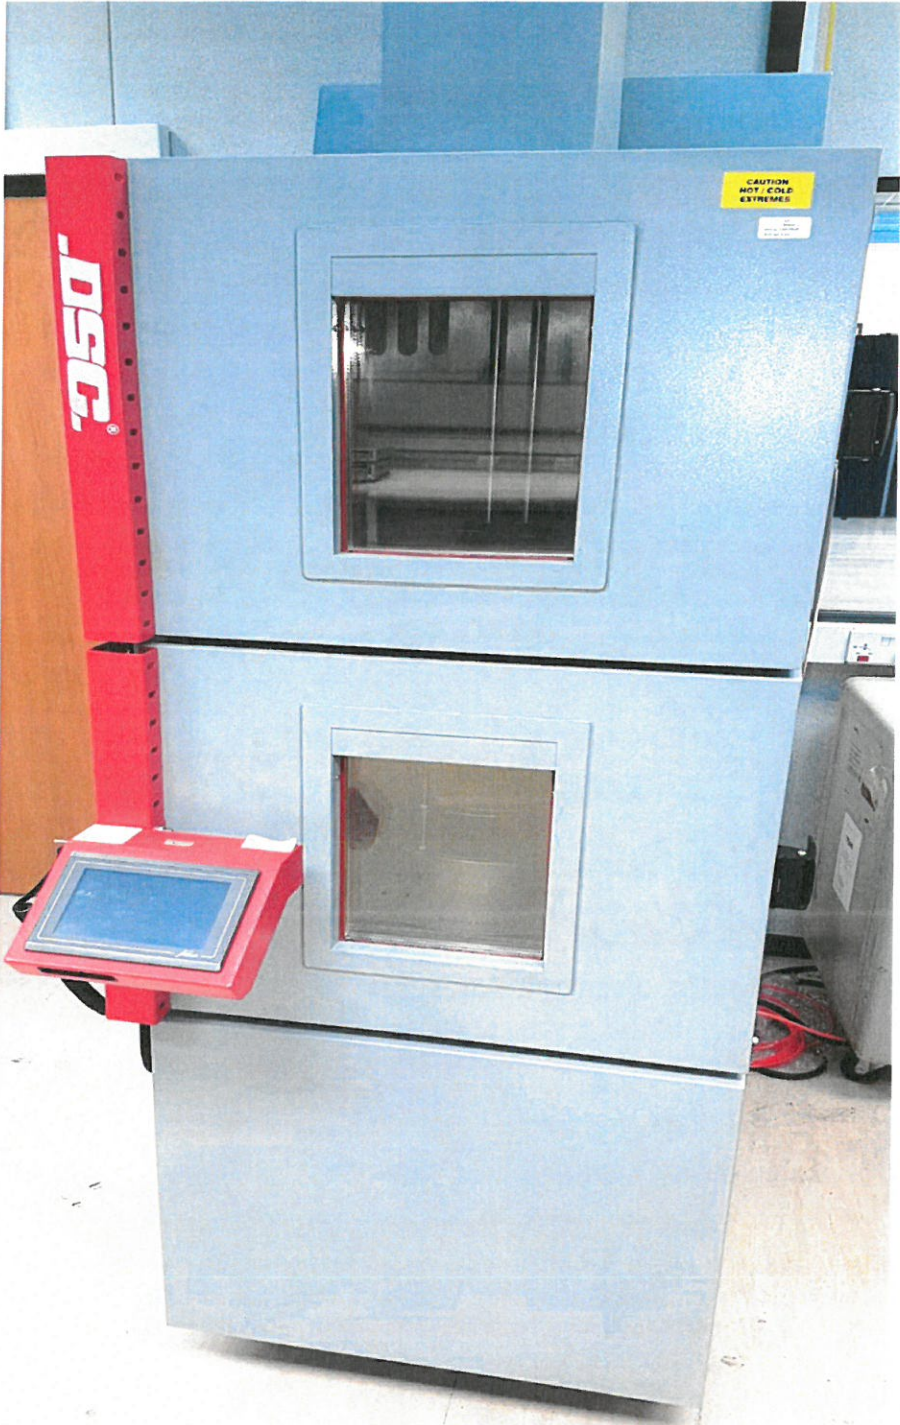
Figure 4: DSC Thermal Shock Chamber

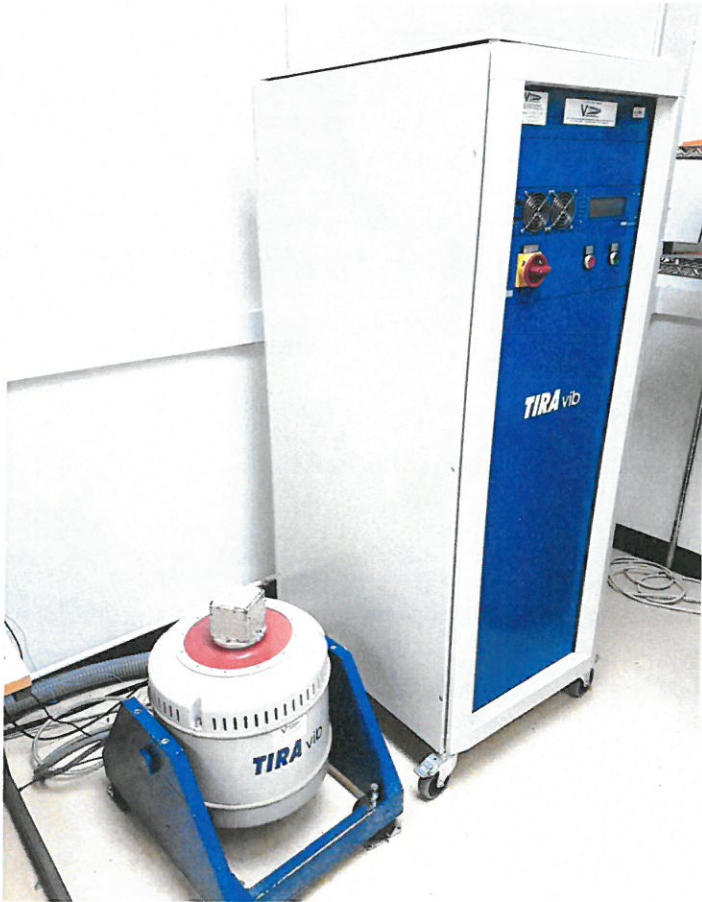
Figure 6: V-TEQ Vibration

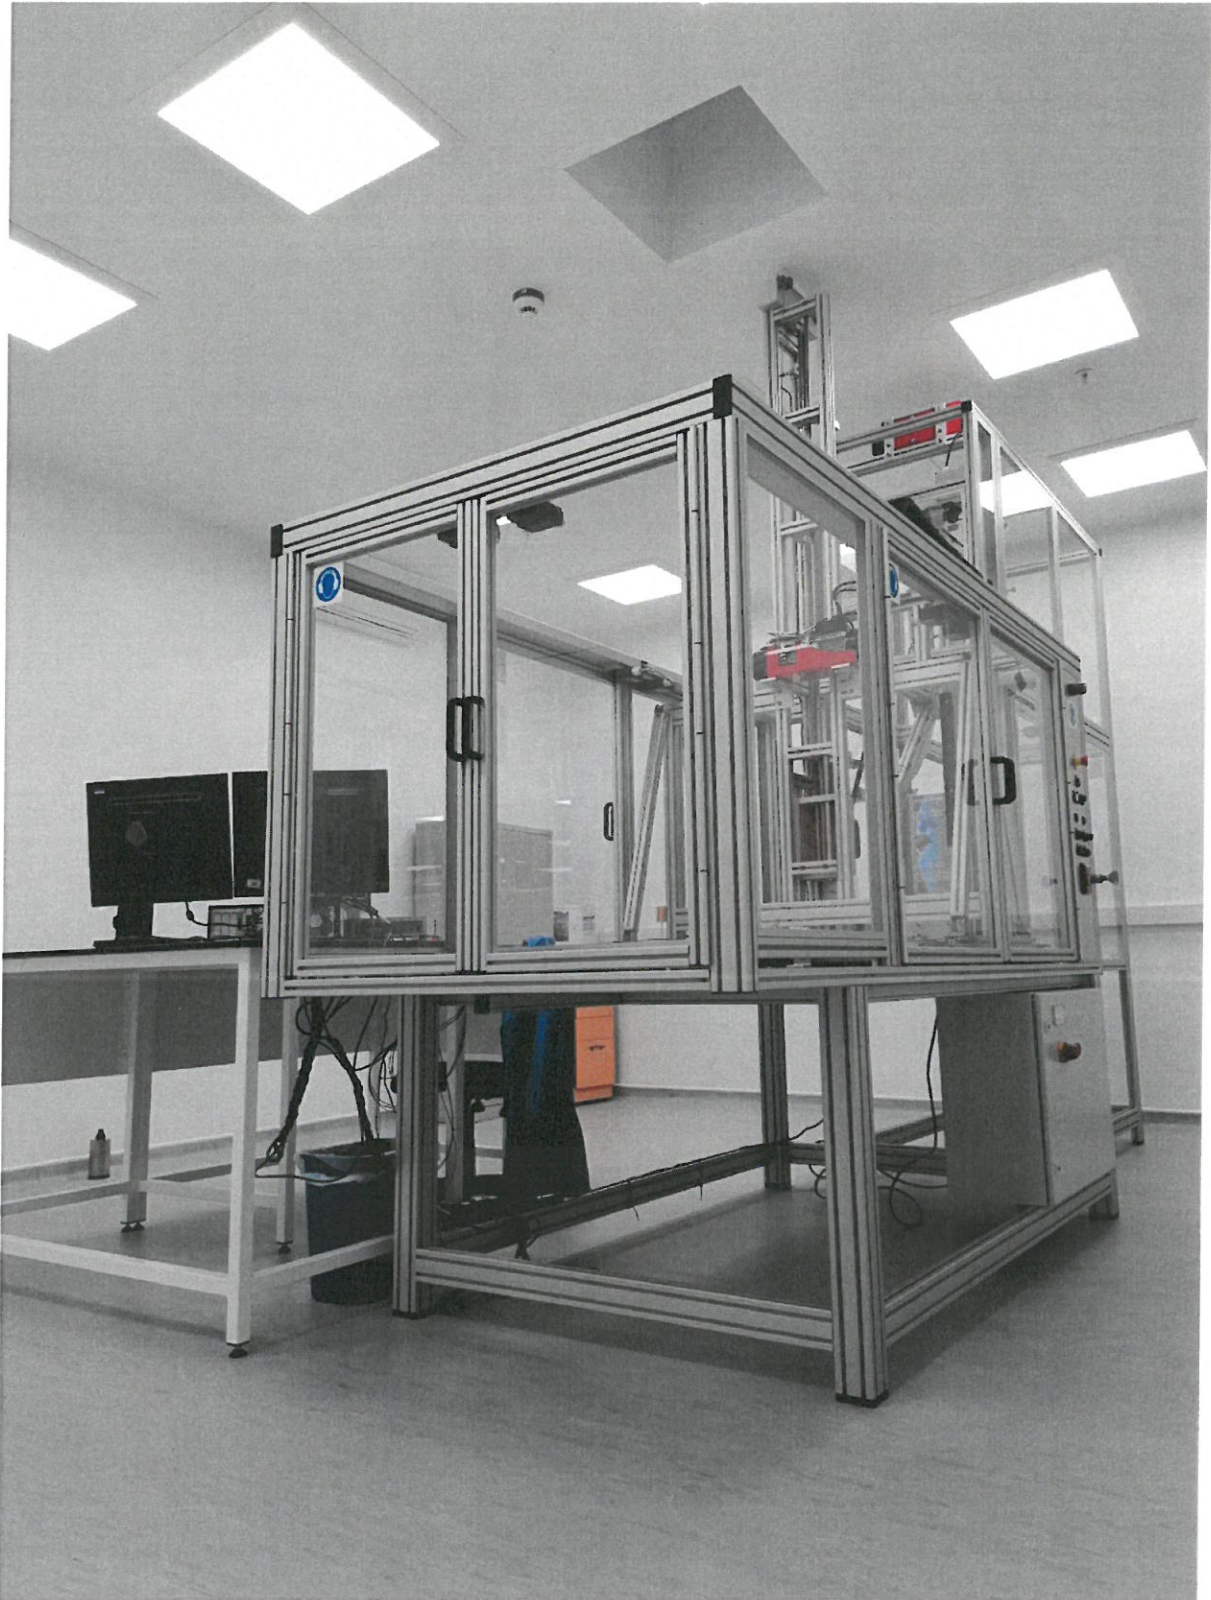
Figure 7: SPTechnologies SRS Shock machine

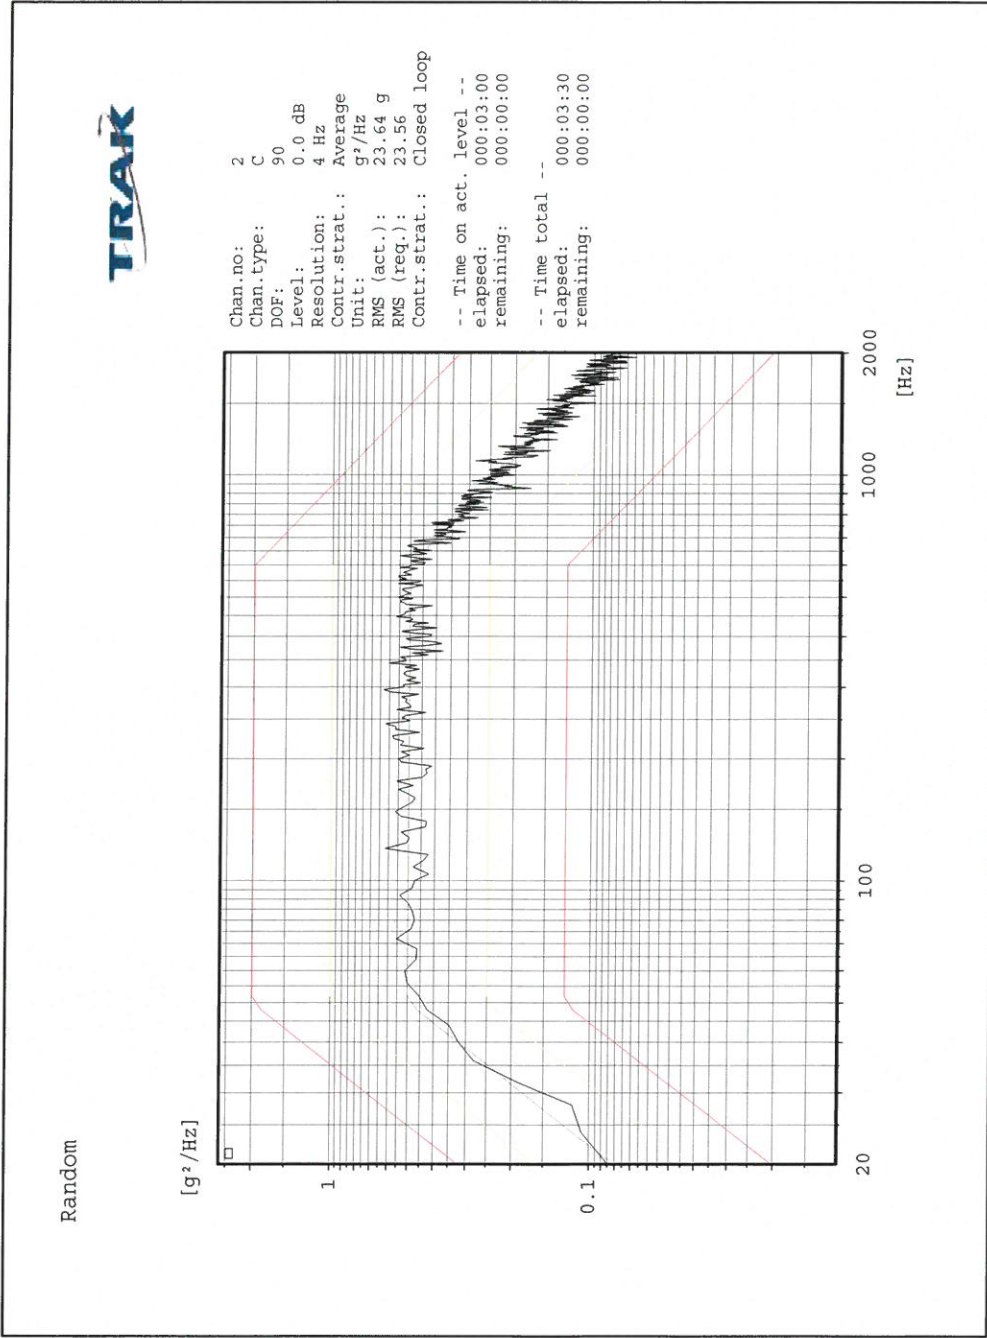
Figure 28: Random Vibration (Typical)
