Smiths Interconnect Qualification Test Report  
Report No: TML\_QUAL\_111  
Revision A

ISO-SPLITTER (1:2)

This document describes the Test Qualification of product XPD303 Iso-Splitter (1:2). An internal platform qualification for Smiths Interconnect.

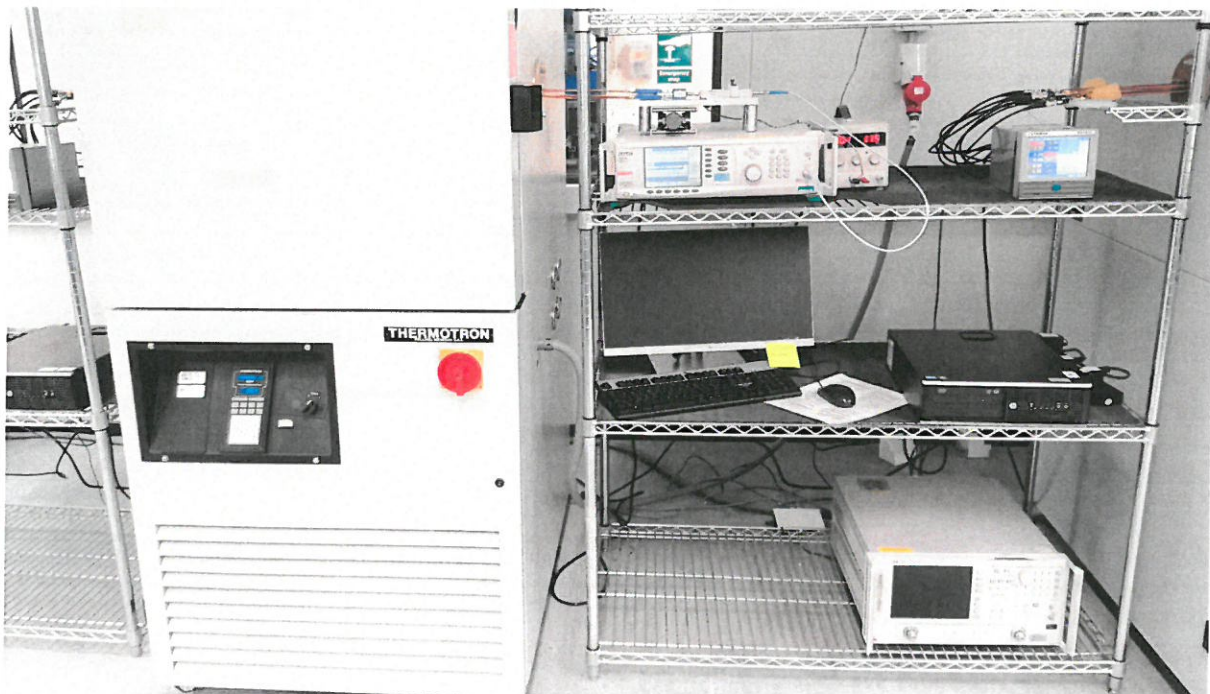
Figure 9: Thermal Glitch setup

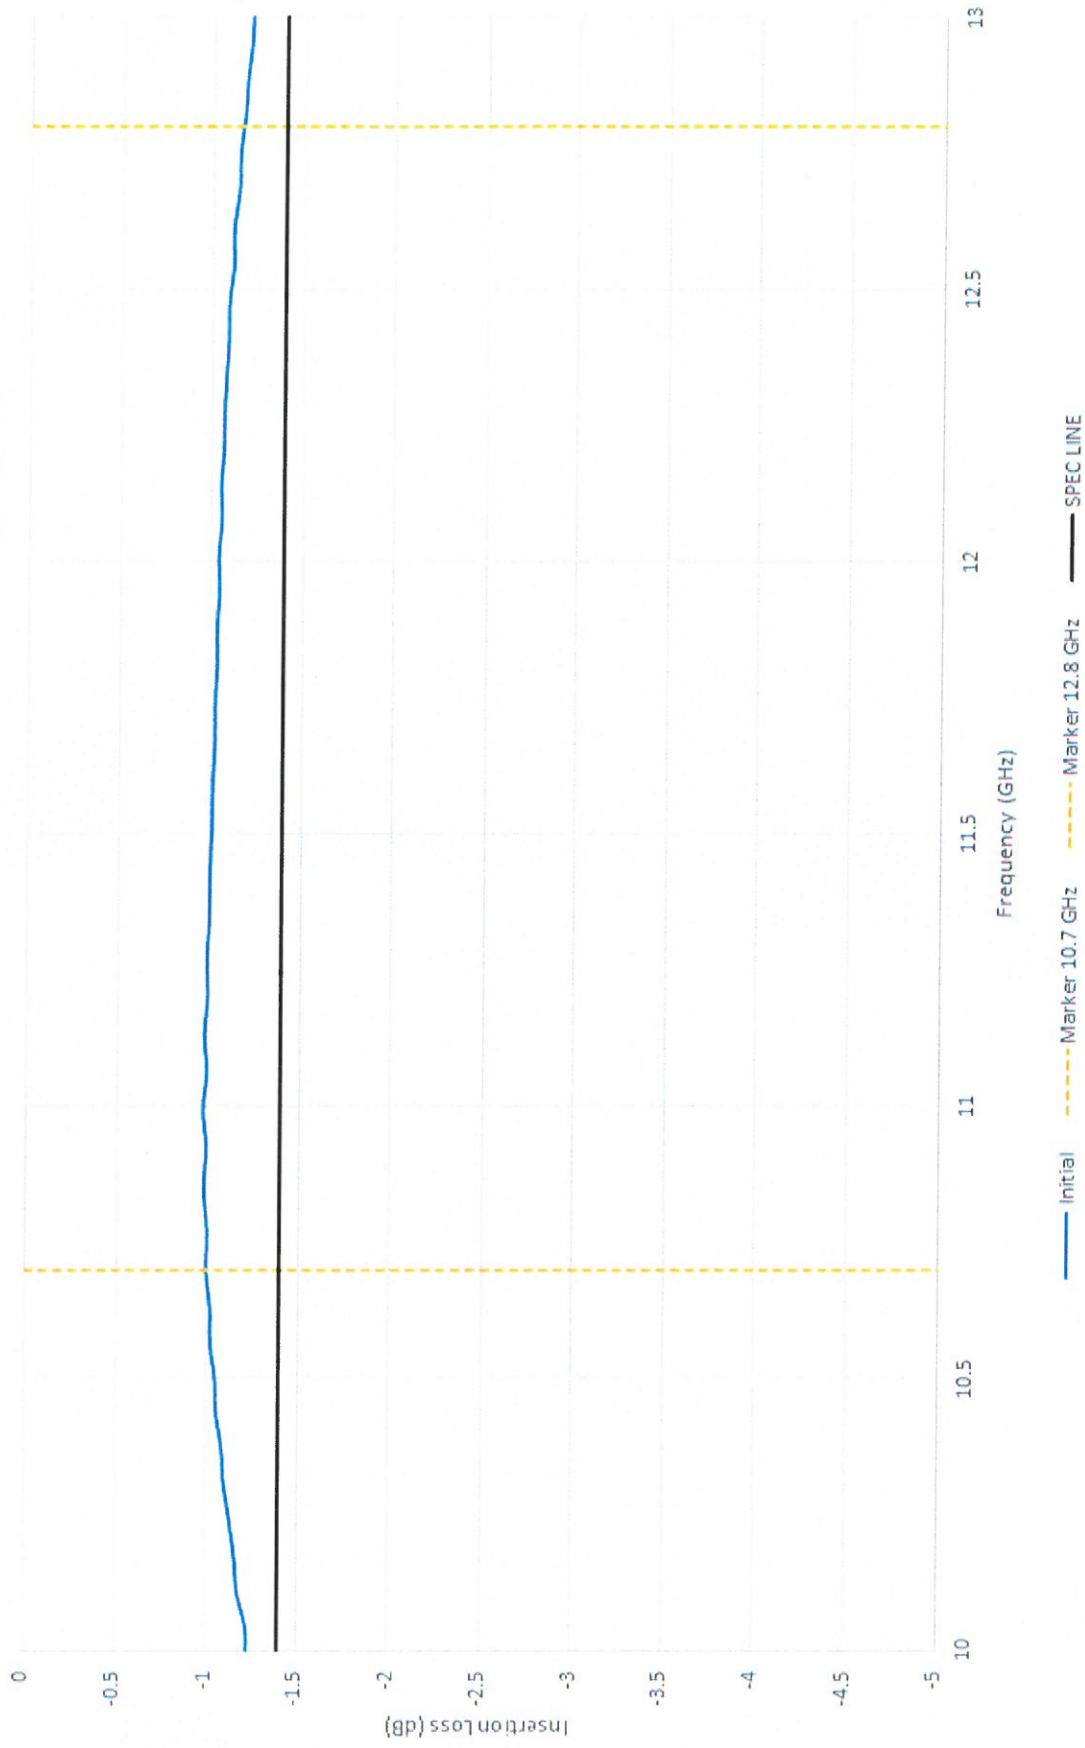
XPD303 Rev B QUAL - Initial Electrical Test - P1-P3 INSERTION LOSS

Figure 24: Insertion loss P1-P3

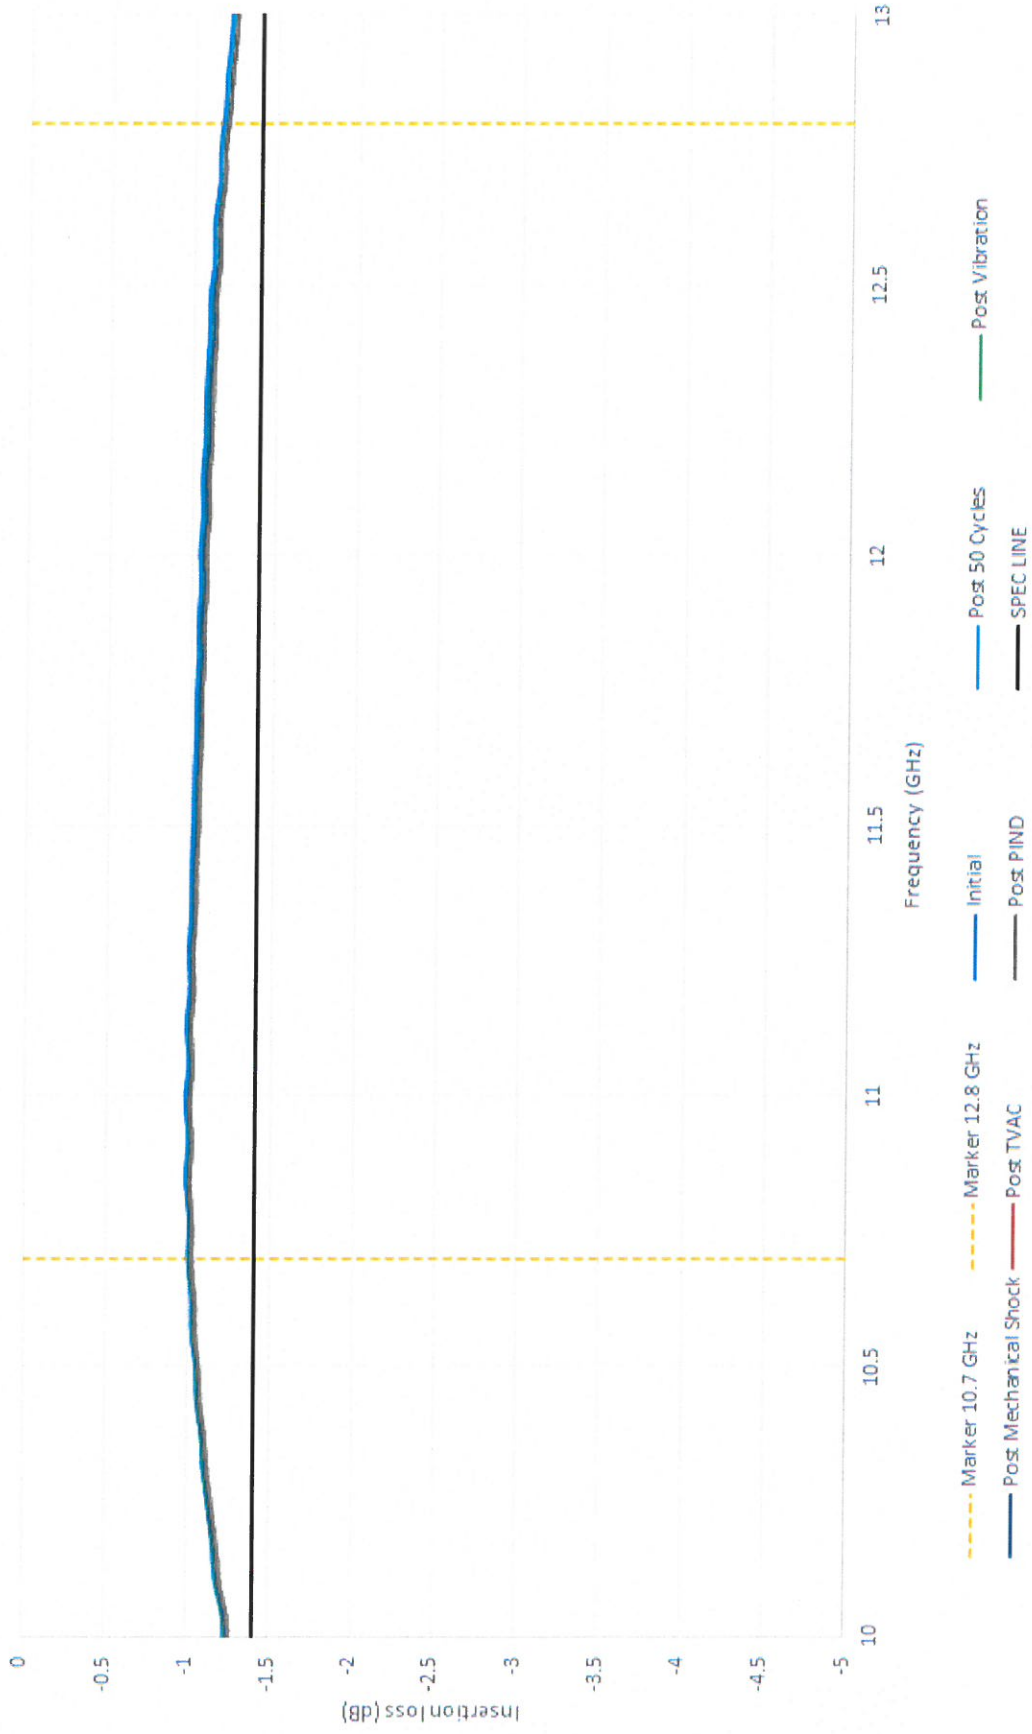
XPD303 Rev B QUAL - Initial vs PTS 50 Cycles vs PTS Vibration vs PTS Mechanical Shock vs PTS TVAC vs PTS PIND - Electrical Test - P1-P3 INSERTION LOSS

Figure 54: Qualification Test Data – Insertion loss P1-P3

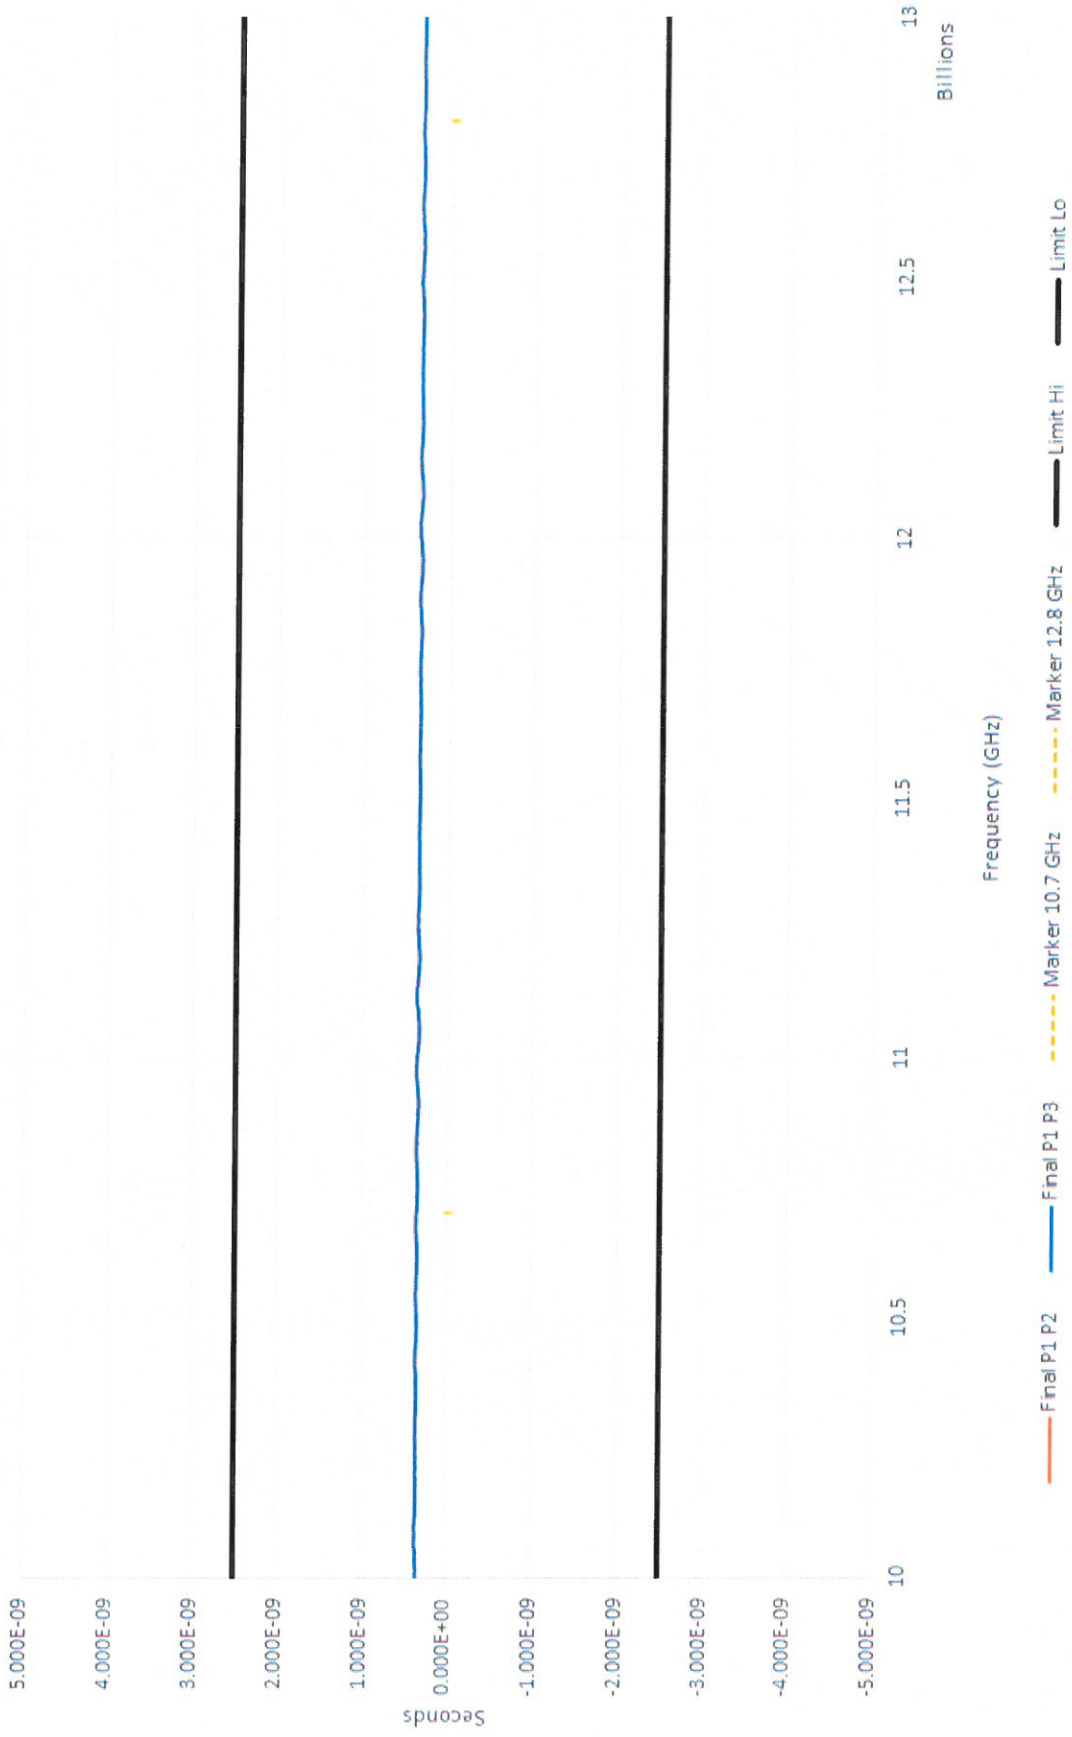
XPD303 Rev B QUAL - Final Electrical Test - P1-P2 / P1-P3 GROUP DELAY VARIATION

Figure 58: Final Electrical Test – Group delay variation P1-P2 / P1-P3
